## Profile Report (Section)

Project Name:  
Union NY Trunk Sewer CCTV

Date:  
1/20/2015

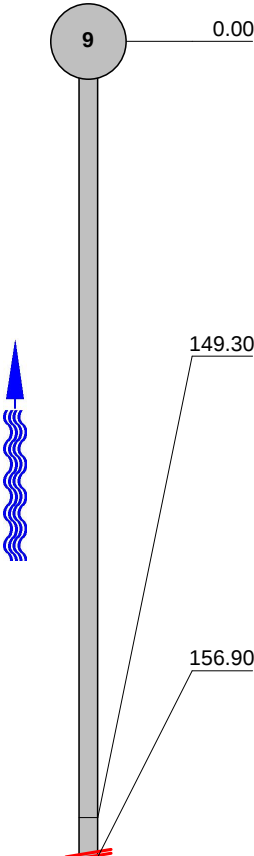
| 1:1453 | Distance | Code | Observation | Counter | Photo | Grade |
|---|---|---|---|---|---|---|
| | 149.30 | MGO | General Observation, HIGH WATER FLOW / HIGH WATER FLOW | 00:13:24 | | |
| | 156.90 | MSA | Survey Abandoned, UNDER WATER / UNDER WATER | 00:14:05 | | |

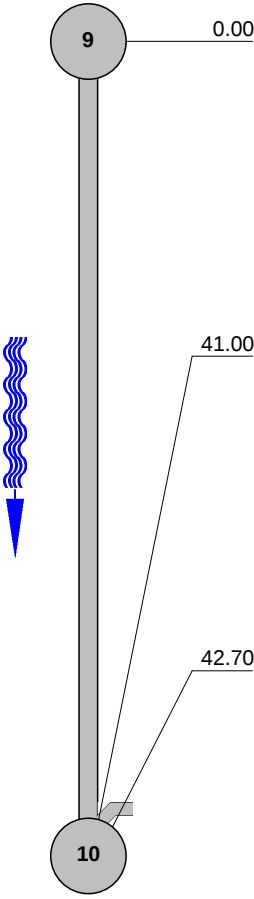
| 1:396 | Distance | Code | Observation | Counter | Photo | Grade |
|---|---|---|---|---|---|---|
| | 41.00 | TBA | Tap Break-In Active at 10 o'clock, 6 inch dim | 00:03:09 | | |

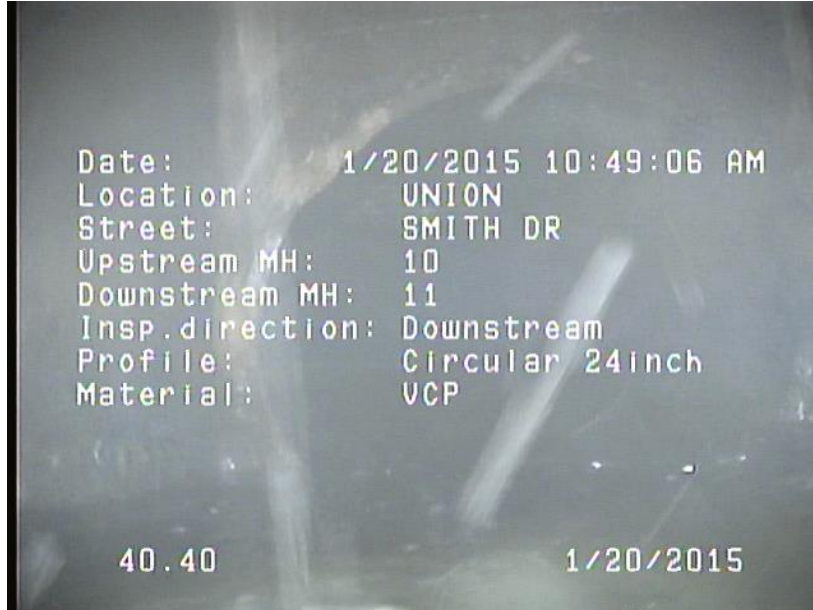
MH10-11\_6c5545e6-659f-47fe-9c4d-151a8f7b1ca9\_20150120\_105632\_441.jpg, 00:05:34,  
40.40  
Manhole, MH11

| 1:375 | Distance | Code | Observation | Counter | Photo | Grade | |
|---|---|---|---|---|---|---|---|
| | 40.40 | AMH | Manhole, MH11 / MH11 | 00:05:34 | MH10-11_6c5545e6-659f-47fe-9c4d-151a8f7b1ca9_20150120_105632_441.jpg | | |

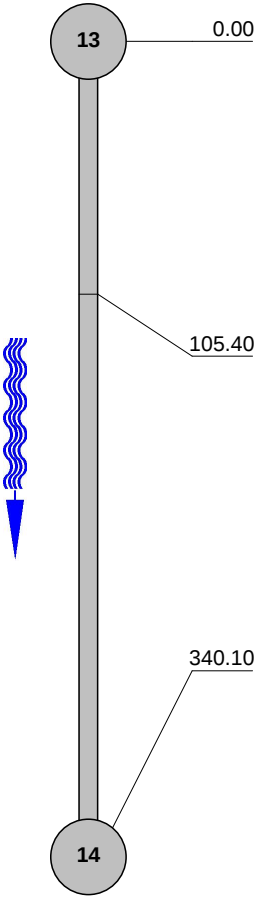
| 1:3150 | Distance | Code | Observation | Counter | Photo | Grade |
|---|---|---|---|---|---|---|
| | 105.40 | TBC | Tap Break-In Capped, at 10 o'clock, -, within 8 inches of joint: NO, 6" | 00:02:32 | | M 2 |

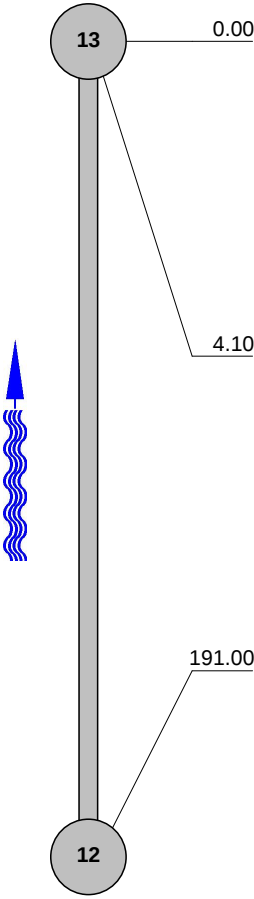
| 1:1769 | Distance | Code | Observation | Counter | Photo | Grade |
|---|---|---|---|---|---|---|
| | 4.10 | TBC | Tap Break-In Capped, at 02 o'clock, -, within 8 inches of joint: NO, 6" | 00:00:25 | | M 2 |

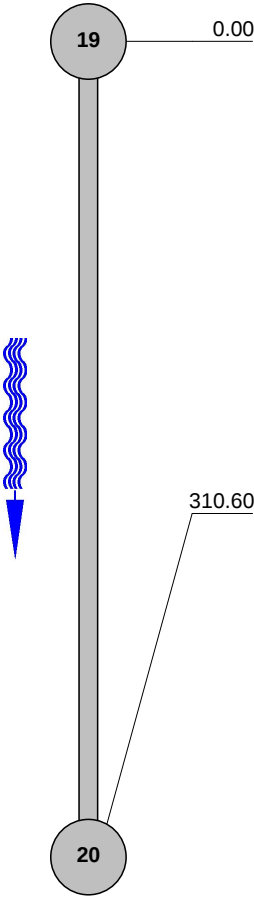
| 1:2876 | Distance | Code | Observation | Counter | Photo | Grade |
|---|---|---|---|---|---|---|
| | 310.60 | MSA | Survey Abandoned / DEBHRIS | 00:08:16 | | |
