## Profile Report (Section)

Project Name:  
Van Auken Russell Road

## Inspection report

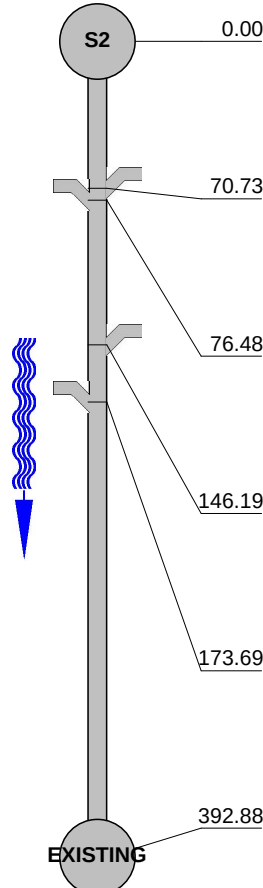
| 1:3638 | Distance | Code | Observation | Counter | Photo | Grade |

| 1:3638 | Distance | Code | Observation | Counter | Photo | Grade |
|---|---|---|---|---|---|---|
| | 0.00 | AMH | Manhole, UPSTREAM MH SURVEY BEGINS / UPSTREAM MH SURVEY BEGINS | | | |
| | 70.73 | TFA | Tap Factory Made Active, at 09 o'clock, 6 inch dim | | | |
| | 76.48 | TFA | Tap Factory Made Active, at 03 o'clock, 6 inch dim | | | |
| | 146.19 | TFA | Tap Factory Made Active, at 09 o'clock, 6 inch dim | | | |
| | 173.69 | TFA | Tap Factory Made Active, at 03 o'clock, 6 inch dim | | | |
| | 392.88 | AMH | Manhole, DOWNSTREAM MH SURVEY ENDS / DOWNSTREAM MH SURVEY ENDS | | | |
