## Profile Report (Section)

Project Name:  
Union NY Trunk Sewer CCTV

Date:  
1/20/2015

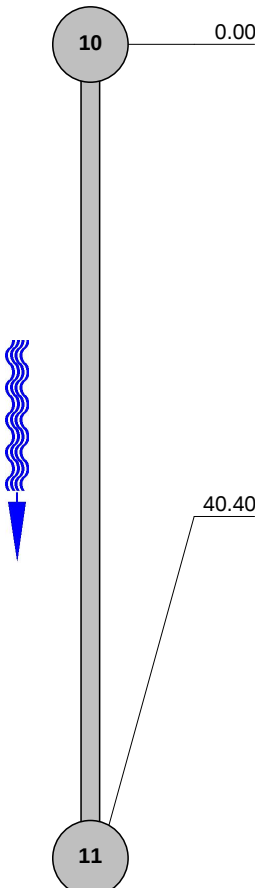
| 1:375 | Distance | Code | Observation | Counter | Photo | Grade | |
|---|---|---|---|---|---|---|---|
| | 0.00 | AMH | Manhole, MH10 / MH10 | | | | |
| | 40.40 | AMH | Manhole, MH11 / MH11 | 00:05:34 | MH10-11_6c5545e6-659f-47fe-9c4d-151a8f7b1ca9_20150120_105632_441.jpg | | |

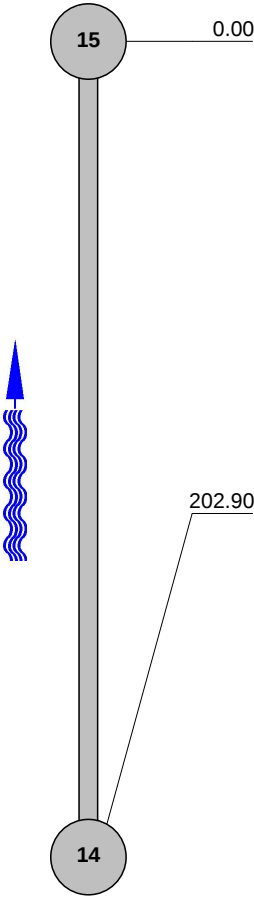
| 1:1879 | Distance | Code | Observation | Counter | Photo | Grade |
|---|---|---|---|---|---|---|
| | 0.00 | AMH | Downstream Manhole, Survey Begins / MH15 | 00:00:15 | | |
| | 202.90 | AMH | Upstream Manhole, Survey Ends / NH14 | 00:20:50 | | |
